Report on the Fracture Mechanics Testing of the Bond between Composite Overlays and Concrete Substrate

REPORT # USC-ME 98-101

Strength, durability and health monitoring aspects of composite overlays on civil engineering structures are discussed. The perspective and benefits of the repair, upgrade, retrofit, and rehabilitation of US civil infrastructure using composite overlays is briefly reviewed. Bond strength, durability, and in-service health monitoring are identified as critical issues blocking the wide acceptance of these novel structural systems in the construction engineering community. A theoretical and experimental research program, set up at the University of South Carolina, is briefly presented. Specimen preparation, test schedules, modeling efforts, and proposed outcomes are discussed. The wider perspective of developing national standards and engineering guidelines for the design and utilization of composite overlays on civil infrastructures is also embraced.

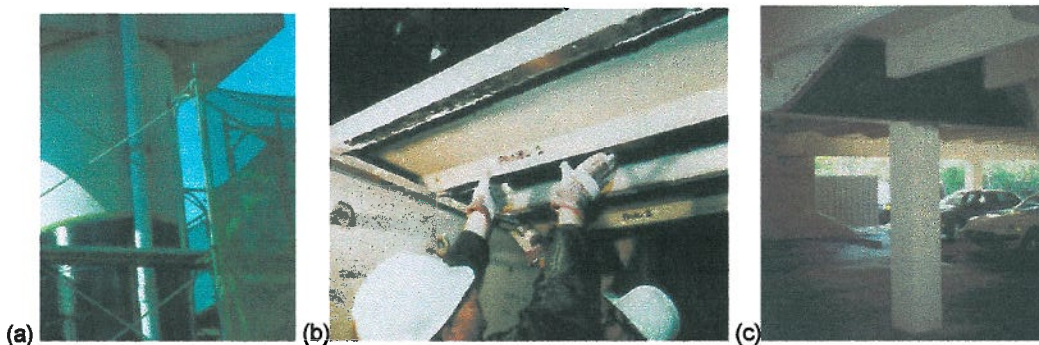
Figure 1 Composite overlay repair/upgrade of civil infrastructure: (a) circumferential reinforcement of a bridge column; (b) bending reinforcement of a concrete deck; (c) shear reinforcement of a parking deck beam (*Composites Design and Applications*, Winter 1996 and January/February 1997).

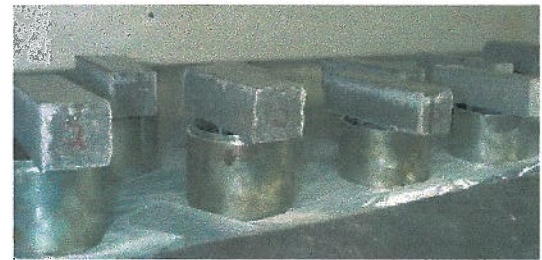
Figure 7 - Primed concrete bricks under the exhaust hood.

After complete cure of the concrete, the bricks were subjected to surface preparation. The bricks were positioned bolts downward. A steel brush was used to remove the loose dust, particles, and cement paste from the upper portion of the bricks. A vacuum was used to remove loose particles from the surface. The cleaned surface was next primed with Atprime 2A+2B supplied by Reichhold Chemicals, Inc., Durham, NC. Atprime is a reactive polyester polyol that cures in the presence of moisture. To reduce exposure to fumes, primer preparation and application was done under an exhaust hood. The primer was prepared by mixing Atprime 2B with Atprime 2A in the ratio 4:1 w/w. Then, the primer was applied to the cleaned surface of the brick using a hand brush. The primed surfaces were allowed to cure overnight (Figure 7).

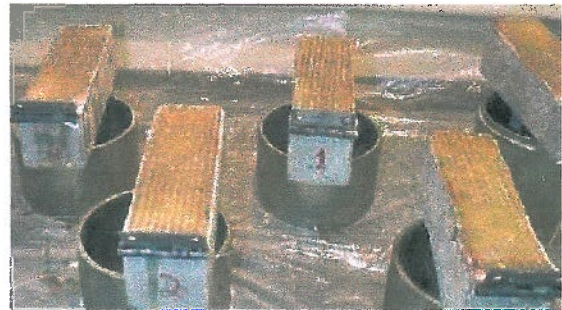
Figure 8 - Apply Composite Overlay

The composite overlay was applied using a wet lay-up process. Atlac 580-10 polyester resin and 46747 peroxide initiator (MEKP type) were used to create the composite matrix material. This resin also served as the adhesive between the composite overlay and the concrete substrate. Both ingredients used in the resin preparation were supplied by Reichhold Chemicals, Inc. The peroxide initiator was thoroughly mixed with the resin (1:80 w/w ratio) in a hand-mixing vessel. Because the gel time of the resin is 25 minutes, it was found that the best to mix enough resin for no more than 6 specimens at a time. The initiated resin was painted onto the brick surface using a disposable paint roller. The first fiber glass section was placed over the surface and a metal roller was used to impregnate the fibers with the resin. Then, a second layer was applied through the same process. After the second layer was applied, the primed metal hinge was placed at the end of the specimen with the rounded pin-side facing downwards. The third and final layer was positioned on top of the specimen, the impregnation process was repeated. This way, the metal hinge was incorporated between the second and the third composite layers. A final coating of resin was rolled onto the surface using the disposable paint roller. This procedure was repeated for all of the specimens. The composite was allowed to cure under normal room temperature and humidity conditions (Figure 8). The composite seemed fully cured and cool to the touch within 2-3 hours after completion. To ensure complete cure, at least 24 hours were left to pass before the specimen was taken to the next stage.

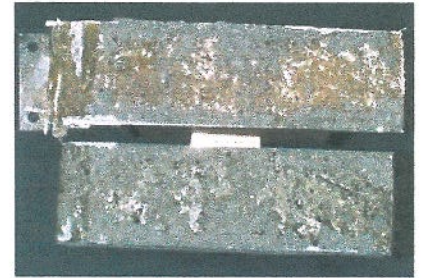
Figure 11 Specimen 2 interface

Specimen 2: Crack propagation occurred as it did in the Specimen 1. The crack grew in the concrete/composite interface along the edges of the specimen (Figure 11). The hinge was slightly off center, due to slipping during lay-up. The top edge retained more concrete, protruding 28-mm toward the center of the specimen, initially. In this region, aggregate was also removed from the top surface of the concrete. When the crack propagated to 60-mm from the hinged edge, concrete paste can be observed as occupying the entire cross section of the composite surface for 40-mm. After this region, the concrete paste resides along the edges of the composite, where more aggregate was removed. 60% of the composite surface contained concrete paste.

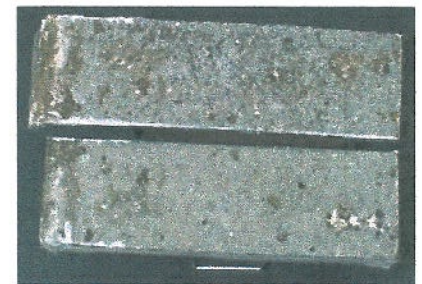
Figure 13 Specimen 4 Interface

Specimen 4: Concrete paste was removed uniformly in the initial crack propagation. When the crack grew to 30-mm from the hinged edge, less concrete paste was detached due to resin pools in the concrete surface (Figure 14). In these areas, the strength of the resin was tested instead of the bond strength. Following these regions, the concrete paste returned to its uniform distribution across the composite surface. When the crack reached 85-mm from the hinged edge, another resin pool was contacted. This particular resin pool contained air pockets that helped enable the removal of concrete from this particular area. Other locations that behaved similarly are located at 122-mm from the hinged edge and at 172-mm. 95% of the composite surface was covered with cement paste.

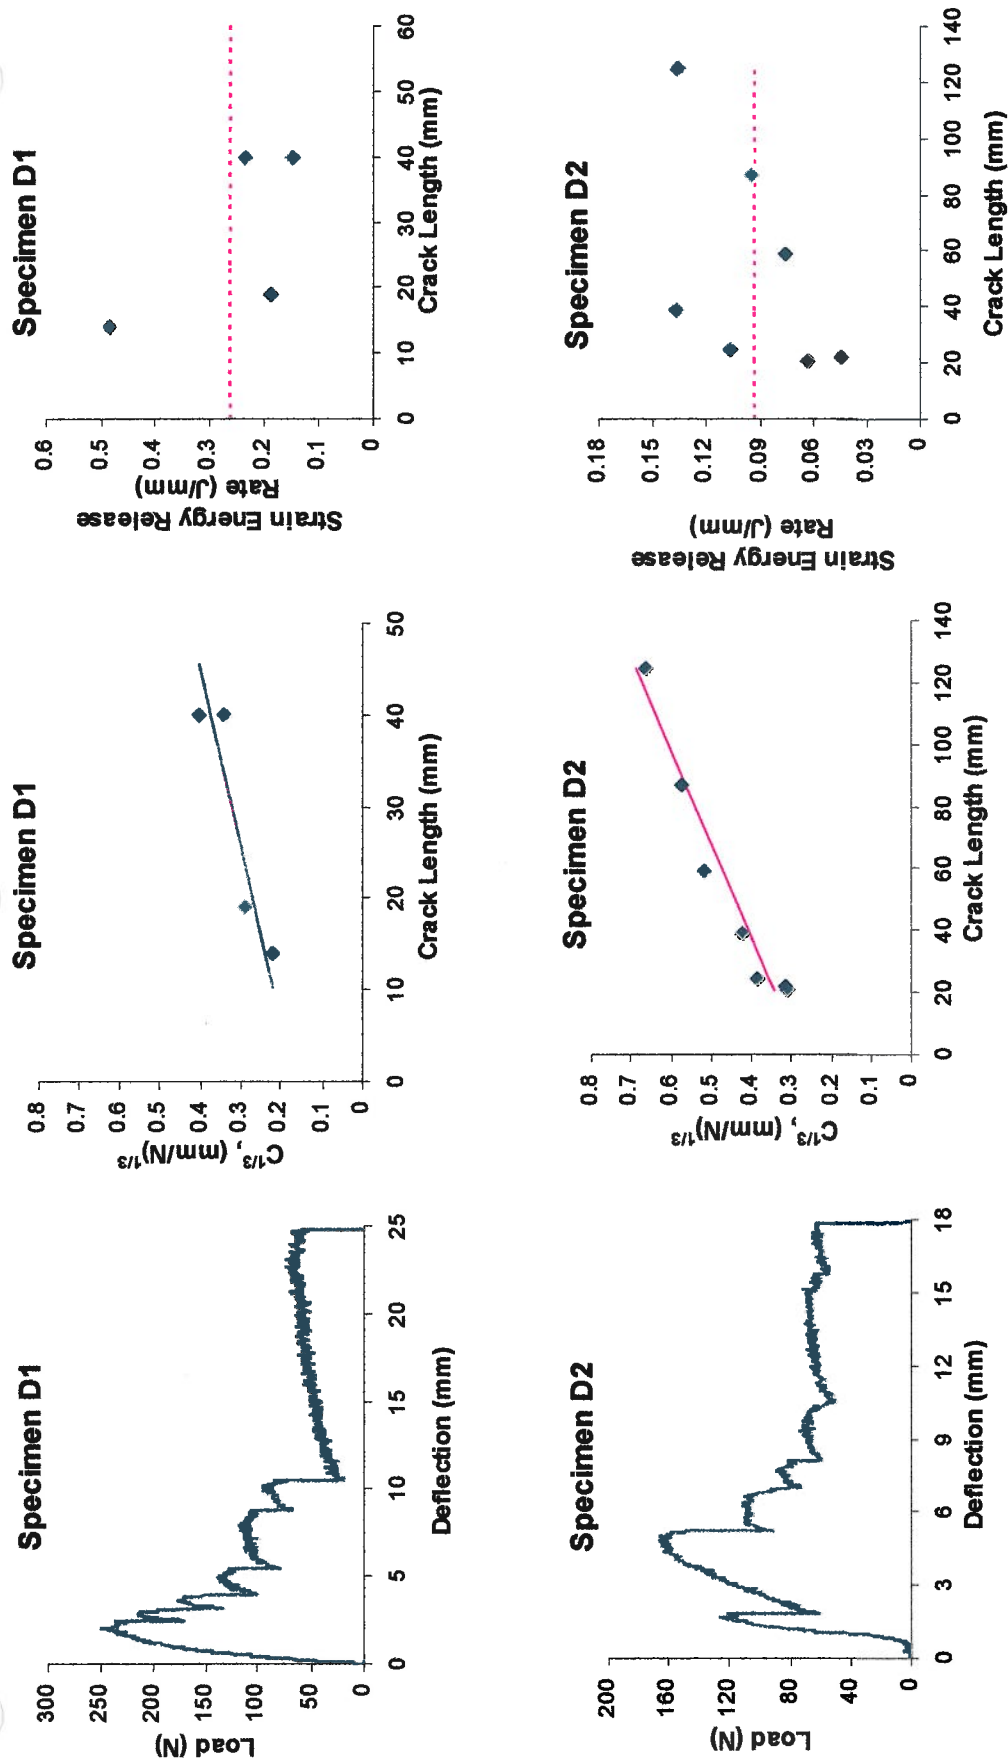
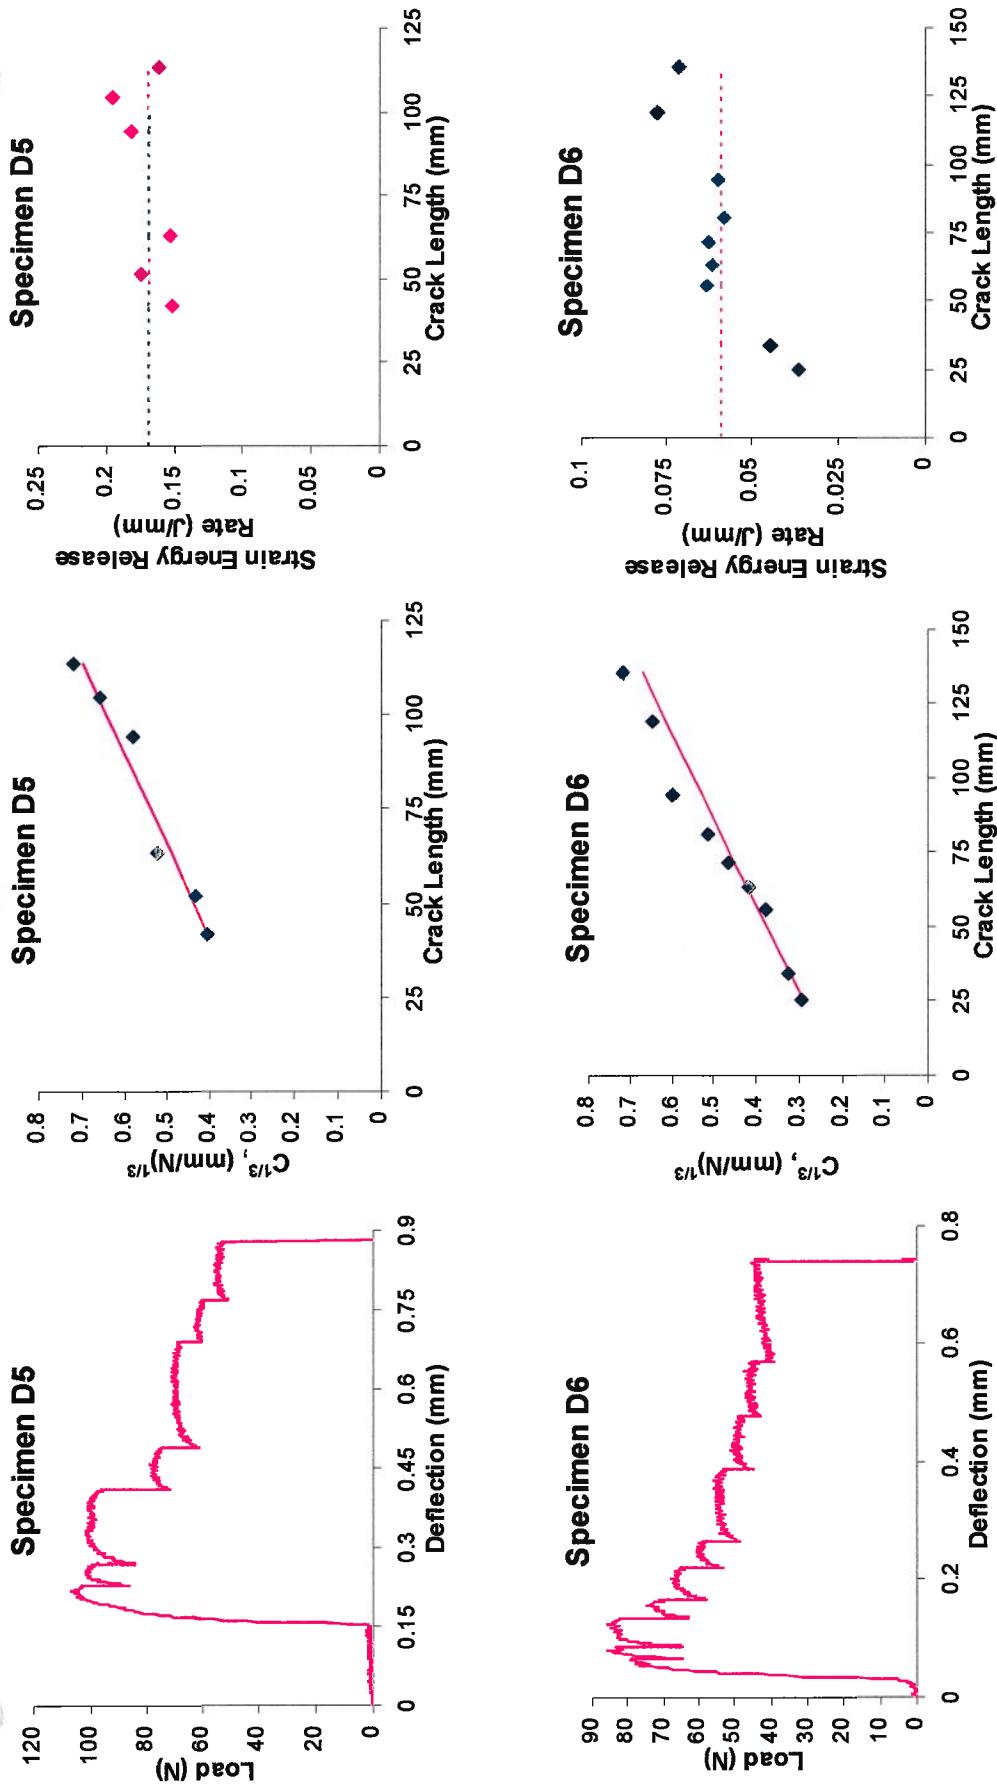
Figure 15 Results of data processing, grouped by specimen numbers

The data files collected during the tests were processed using MS Excel software. First, load-displacement graphs were produced. These graphs clearly indicated the loading cycles and the crack propagation regions. Next, plots of the cubic root of compliance vs. crack length were generated and a least-squares straight line fit was applied. These graphs correspond to equation (10) and generate the m and n values necessary for the calculation of SERR, G , with Equation (11). In producing these fits, attention was paid to the elimination of outliers that would distort the results. Finally, the fitted m and n values were used in Equation (11) to generate graphs of SERR, G , vs. crack length, a . The results of data processing are presented in Figure 10. Three graphs are presented for each specimen: (a) the as-recorded load-displacement plot; (b) linear fit between the cubic root of compliance, $C^{1/3}$, and the crack length, a ; and (c) the plot of strain energy release rate, G , as function of crack length, a . The $C^{1/3}$ - a plots show very little scatter and indicate a good linear fit of the data and confirm the soundness of the experimental method. The G - a plots show some data scatter. The arithmetic mean value of G for each specimen was superpose on the G - a plots.

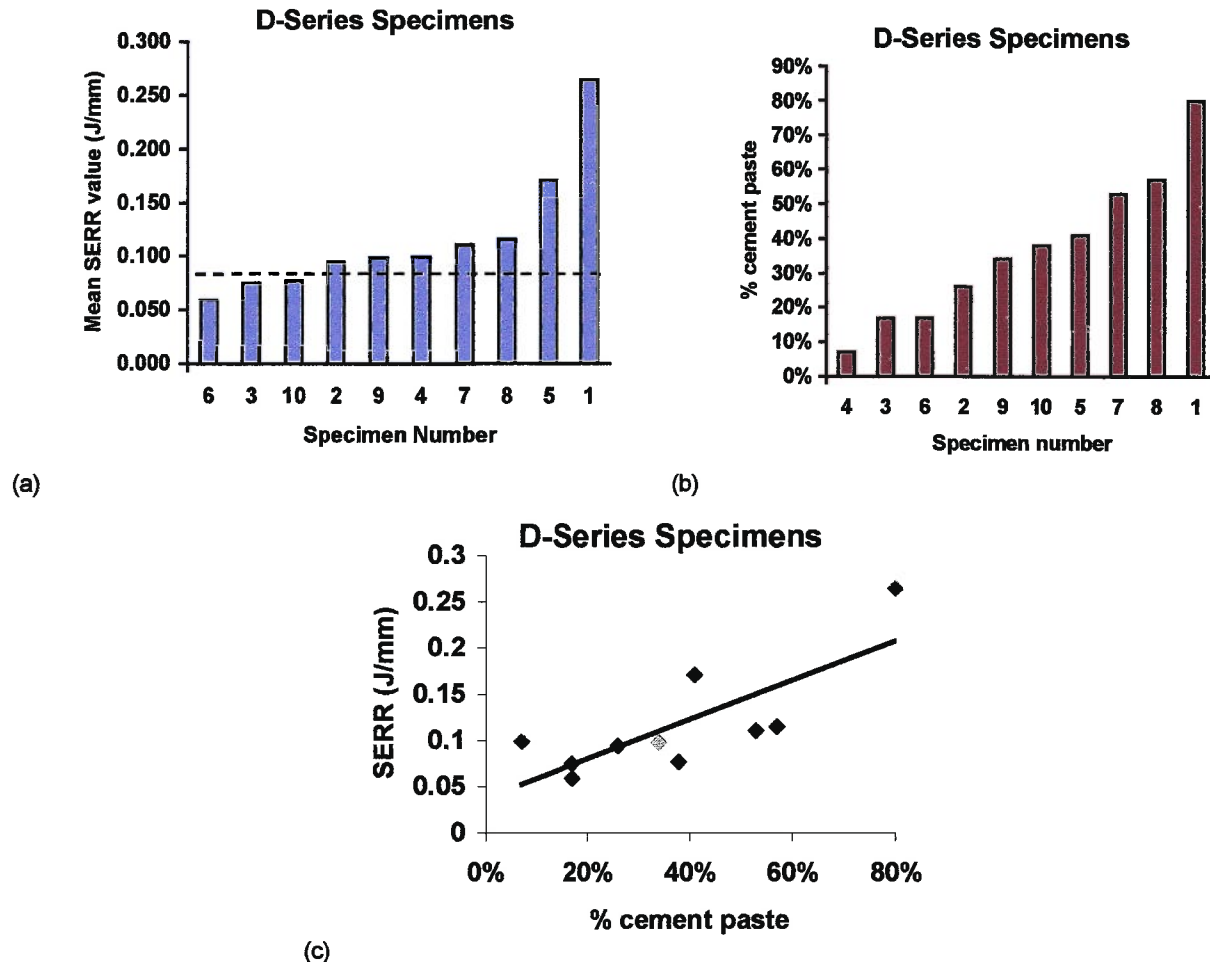
Figure 16 Synoptic representation of the test results sorted out in ascending order: (a) mean strain energy release rate (SERR) values; (b) percentage of fracture surface presenting cement paste retention (c) correlation between mean SERR and % cement paste.

Table 5 gives the mean values of strain energy release rate (SERR) resulting for the testing of the ten D-series specimens. A plot of these results, ordered by increasing SERR values is given in Figure 11a. Examination of Figure 11a reveals that most of the specimens displayed a mean SERR value around $G_{\text{average}} = 0.1 \text{ J/mm}$. Some specimens (e.g., #3 and #6) displayed a value less than 0.1 J/mm . Other specimens (e.g., #5 and #1) displayed a value well above 0.1 J/mm . Our contention is that the value $G_{\text{average}} = 0.1 \text{ J/mm}$ could be considered as an average value for the first set of specimens. However, some discussion of the outliers is useful to understand (a) the causes of reduced toughness of the bond between composite and concrete; and (b) ways to improve the fracture toughness and strengthen the composite/concrete bond.

Examination of data for specimen #1 indicates that this specimen also had much larger levels of load during the test. This indicates an overall stronger adhesion. The percentage of fracture surface retaining cement paste after fracture is also highest in this specimen (Figure 11b). This indicates that a good bond was created between the composite and the substrate during the wet lay-up process. Thus, when cracking took place during the test, the crack was forced to propagate in the concrete substrate. Since the cement paste present in the upper layer of the concrete substrate is weaker than the rest of the concrete, the crack propagation was taken place in the cement paste layer. As shown in Figure 11a, this type of crack propagation yields the highest fracture toughness. Examination of specimen #5 also shows a significant percentage of the fracture surface being covered with concrete paste (Figure 11b). However, the ranking of specimen #5 in terms of the percentage of concrete paste coverage on the fracture surface is lower than its ranking in terms of fracture toughness. This indicates that the percentage of concrete paste coverage on the fracture surface is not the only indicator of a strong bond, and that other factors (confounders effect and/or modifiers) are involved.

D-Series Specimens with Lower-than-average SERR: Specimens #3, #6, and #10 had lower-than-average strain energy release rate values (Figure 11a). Of these, specimens #3 and #6 are also the specimens with the lowest percentage of concrete paste coverage of the fracture surface. From this point of view, these specimens confirm that a significant correlation exists between the fracture toughness and the percentage of cement paste coverage of the fracture surface. On the other hand, specimen #10 has a different behavior. Its ranking in terms of the percentage of cement paste coverage of the fracture surface is higher than its ranking in terms of fracture toughness. This observation proves again that, though a significant correlation exists between bond fracture toughness and percentage of cement paste coverage left on of the fracture surface, other factors, confounders effect and/or modifiers, are also involved.

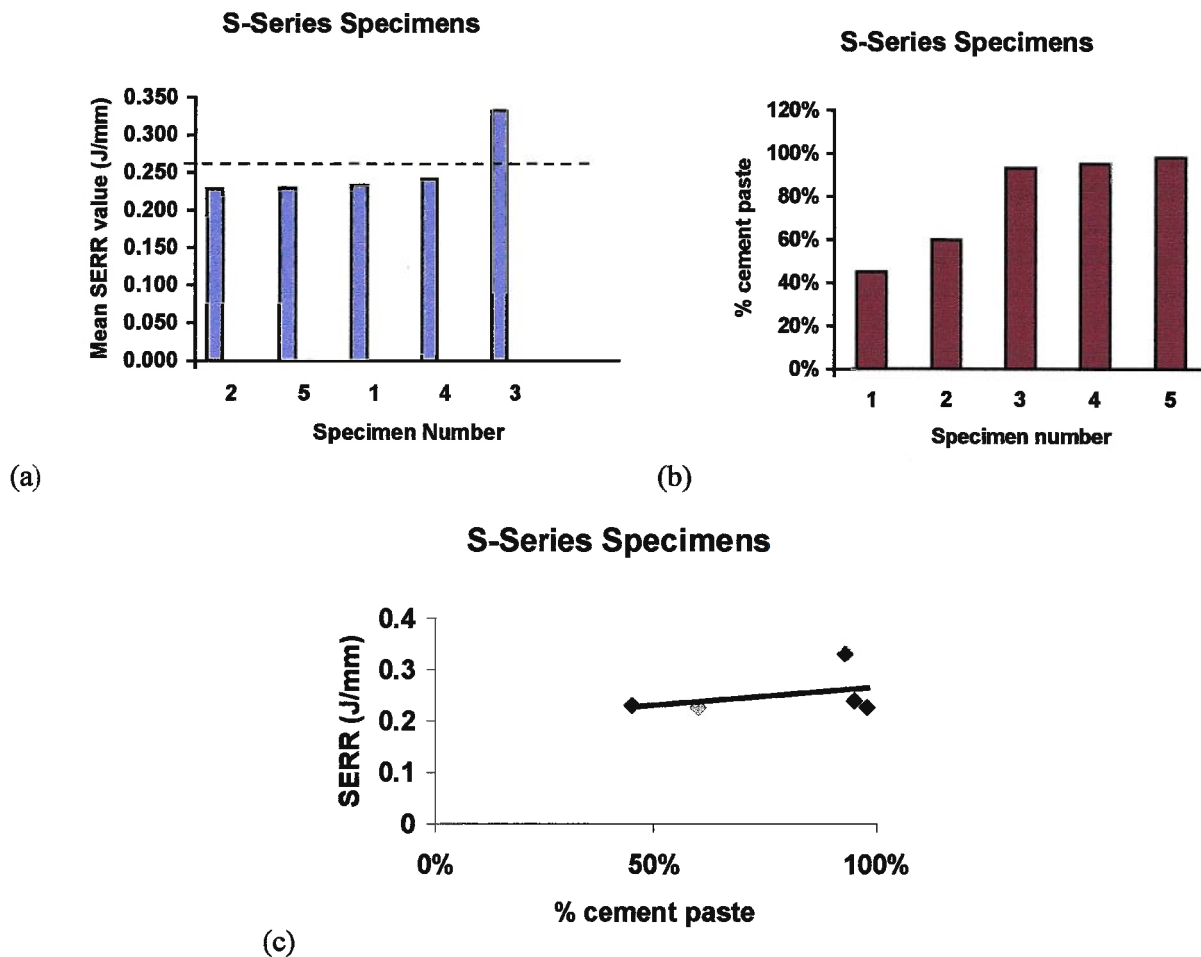
Figure 17 Synoptic representation of the test results sorted out in ascending order: (a) mean strain energy release rate (SERR) values; (b) percentage of fracture surface presenting cement paste retention; (c) SERR vs. percentage cement paste.

Table 6 gives the mean values of strain energy release rate (SERR) resulting for the testing of the five S-series specimens. A plot of these results, ordered by increasing SERR values is given in Figure 11a. Examination of Figure 11a reveals that most of the specimens displayed a mean SERR value around $G_{\text{average}} = 0.252 \text{ J/mm}$. Some specimens (e.g., #3 and #6) displayed a value less than 0.1 J/mm . Other specimens (e.g., #5 and #1) displayed a value well above 0.1 J/mm . Our contention is that the value $G_{\text{average}} = 0.252 \text{ J/mm}$ could be considered as an average value for the second set of specimens. However, some discussion of the outliers is needed to understand (a) the causes of reduced toughness of the bond between composite and concrete; and (b) ways to improve the fracture toughness and strengthen the composite/concrete bond.

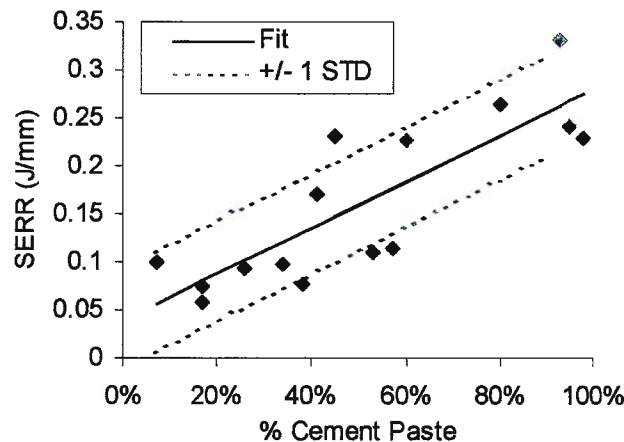
Figure 18 Correlation of strain energy release rate (SERR) with percentage cement paste retained on the faying surfaces after debonding

The amount of cement paste adhered to the overlay was quantified by measuring its area percentage using a statistical point counting method. When SERR is plotted against the percentage of cement paste adhered to the overlay, as in Figure 18, it is clear that a correlation exists. In this figure, the data and the regression line show that SERR increased with an increased amount of cement paste adhered. The r^2 statistic of the regression line was low, however ($r^2 = 0.65$), due to several outliers. For example, three samples with % cement paste values between 40 and 60% fell below 1 standard deviation of the regression line. Closer examination of the fracture surfaces of these samples indicates that they had large debond areas, whereas the debond areas on the other samples tended to be smaller and more equally distributed on the surface. On one of these samples, one side of the overlay was almost bare of cement paste but the other side was almost completely covered with it. While the trend of increasing SERR with increased percentage of cement paste adhered exists, these observations indicate that the distribution of the debonds also plays an important roll in determining the effective toughness of the composite-to-concrete bond.
