Towards the generation of controlled one-inch impact damage in thick CFRP composites for SHM and NDE validation

Robin James^{*}, Victor Giurgiutiu

In this paper, an attempt has been made to conduct controlled low velocity impact experiments in quasi-isotropic carbon fiber reinforced polymer (CFRP) composites of increasing thicknesses to generate barely visible impact damage (BVID) that creates 1" impact damage diameter. Such impacted CFRP coupons with controlled damage diameter would serve in the future for validation of structural health monitoring (SHM) and nondestructive evaluation (NDE) damage detection methodologies. Various 2-mm, 4-mm and 6-mm thick quasi-isotropic CFRP composite plates having similar stacking sequence were manufactured in a compression molding machine. These plates were cut into numerous 6" × 4" coupons to be impacted in accordance with ASTM D7136 standard on a Dynatup impact testing machine. The goal of the experiments was to identify the combination of impactor mass, energy and momentum at which approximately 1" impact damage diameter could be produced for test coupons of increasing thicknesses. Interesting observations were made with respect to the size

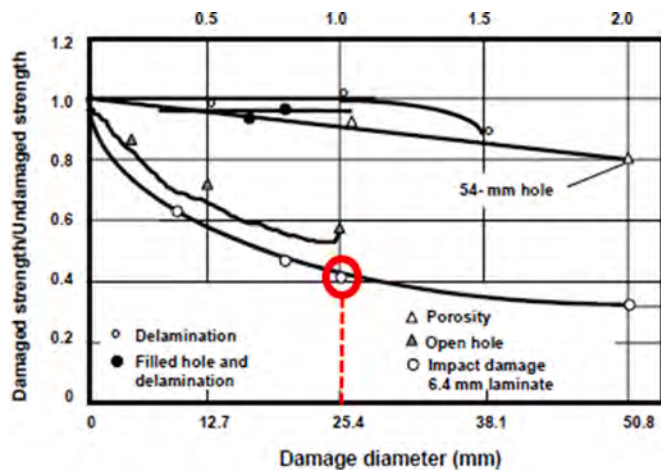
Fig. 1. Effect of impact damage diameter on compressive strength of composite [25].

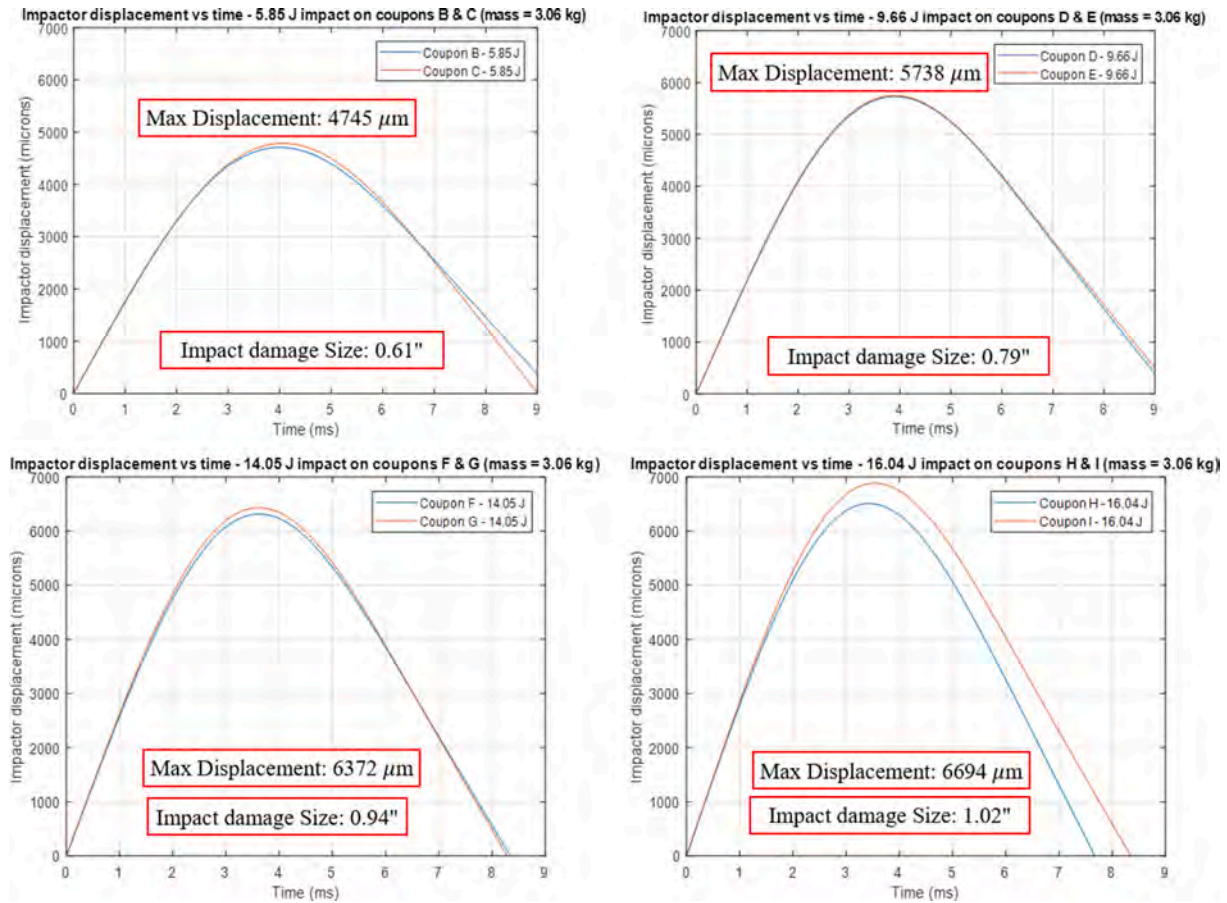
Fig. 9. Displacement-time history of $[-45/90/+45/0]_{2S}$ coupons.

The velocity-time history of the impact events in the 2-mm coupons begins from being positive initially as the impactor is dropped towards the coupon then it becomes zero upon contacting the coupon and becomes negative as the impactor rebounds from the coupon and moves upwards. The negative velocity indicates the upward rebounding of the impactor after impacting the coupon. The displacement-time history of the coupons begins from zero and becomes maximum upon contacting with the impactor and then goes back to zero as the impactor is rebounded upwards as can be clearly observed in Fig. 9. We can clearly observe that the maximum displacement is obtained in coupons H and I

for an impact energy of 16.04 J, which causes an internal delamination size of 1".

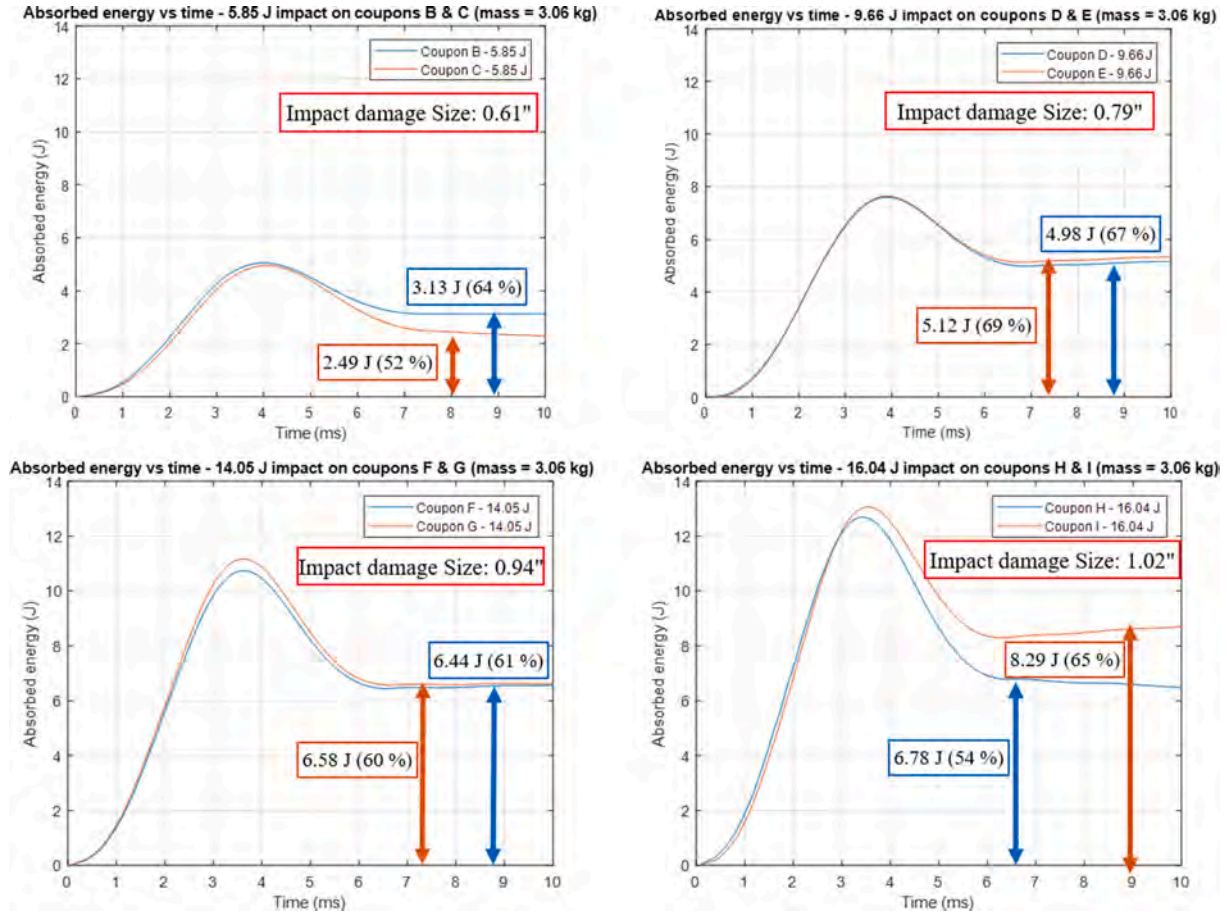
Fig. 10. Energy-time history of [-45/90/+45/0]_{2S} coupons.

The energy-time plots given in Fig. 10 are taken from the force-time curves through integration of the data. The energy-time plots better describe the peak energy experienced and energy absorbed by the coupons. Here, the energy absorbed is the difference between the value at the end of the plot and the initial value. The difference between the peak energies observed and the energy absorbed can be used to determine the efficiency of energy absorption by the material. Furthermore, the energy-time history clearly is able to demonstrate the percentage of impact energy that is absorbed by the coupon to create the irreversible process of damage. For coupons H and I where 1" impact damage diameter is formed, over 65% of the impact energy is absorbed by the coupons.

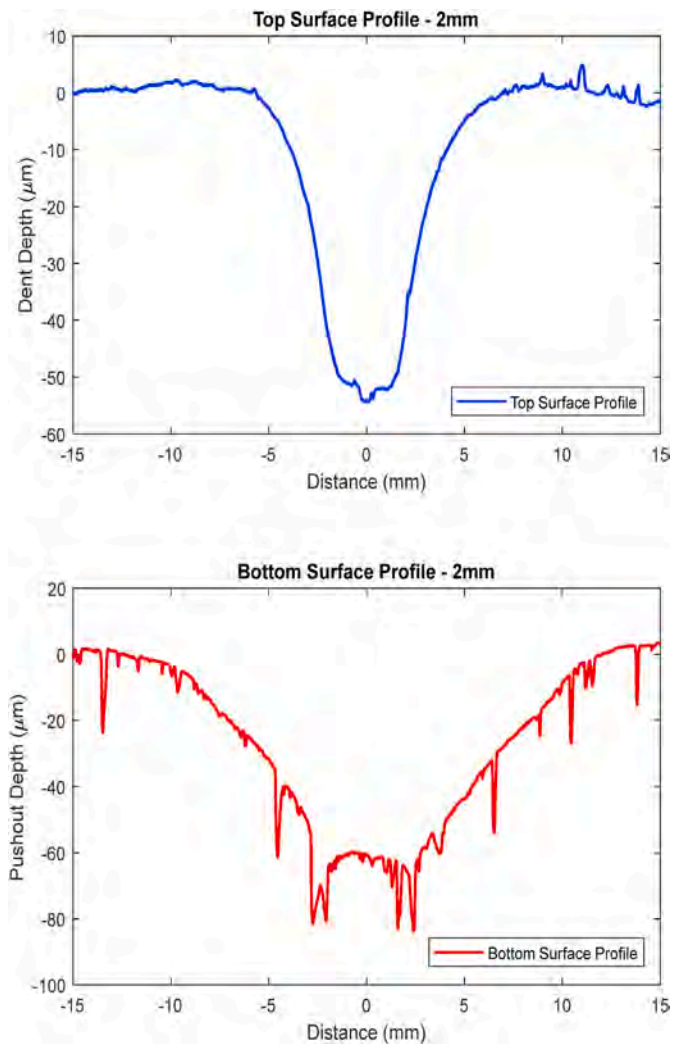
Fig. 15. Profilometry scans of 2-mm coupon: (a) Top surface; (b) Bottom surface.

Profilometry scans of coupon I which produced a 1" damage were conducted using a Veeco Dektak 3ST surface profiler to observe the profile of the top and bottom surface after impact. The profilometry images are displayed in Fig. 15. Using the top surface scan we were able to estimate that the dent depth is approximately $54\text{ }\mu\text{m}$ and using the bottom surface scan we were able to estimate the pushout height as $80\text{ }\mu\text{m}$. Some of the irregularities in Fig. 15 (b) can be attributed to the rough bottom surface of the composite. This roughness appears due to

the fact that the caul plates used to manufacture this coupon were not smooth and the impressions on the surfaces of the caul plates were imprinted on the coupon thereby making it rough with irregularities. This roughness was fixed in subsequent manufacturing of the composite plates. It is also interesting to observe that the dent profile seems hemispherical with a small dimple. The dimple is attributed to the tup

which was used for the impact and was not ground well.

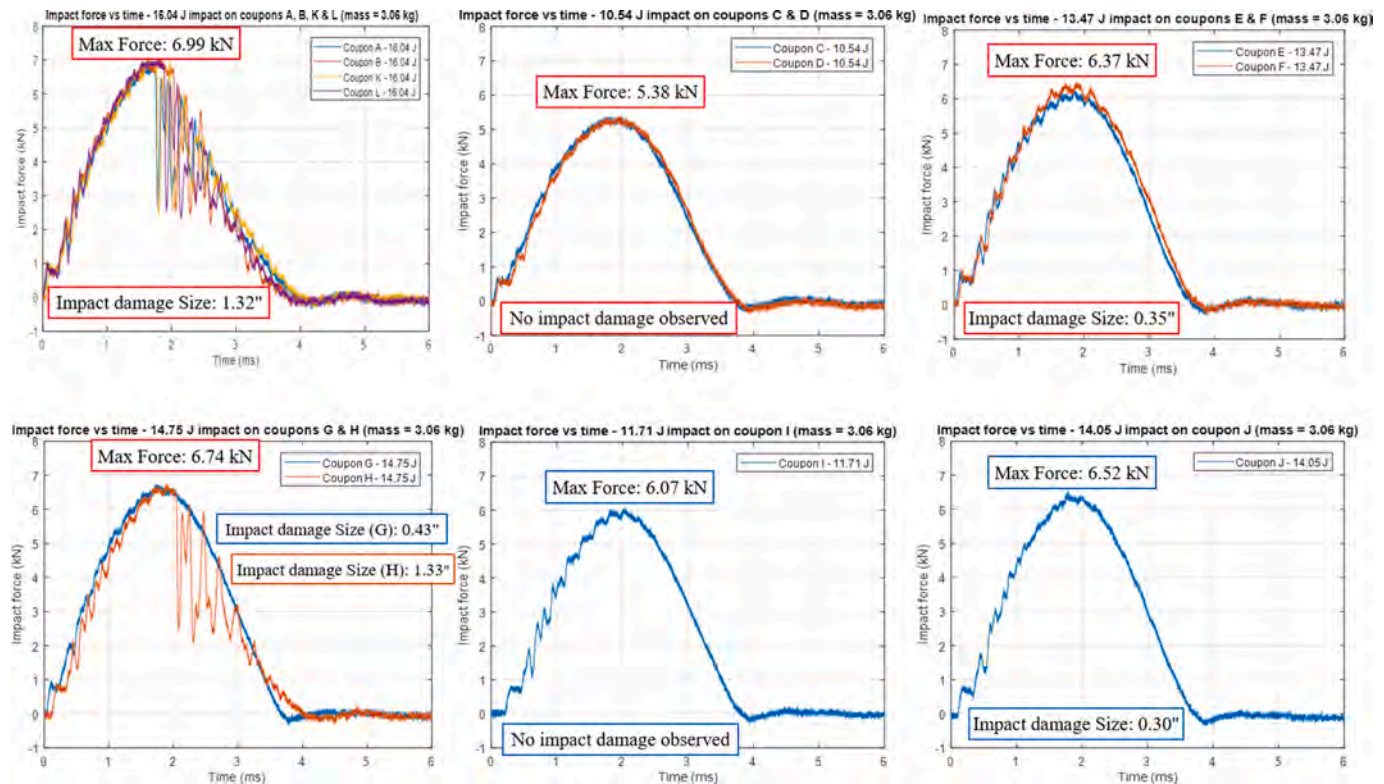
**Fig. 16.** Force-time history of [45/90/+45/0]_{4s} coupons.

The force-time history of the impacts is given in Fig. 16. The load curve shows peaks at certain maximum load and is parabolic in shape. When the load curve is symmetric, its shape indicates that the impact energy is primarily deflected and little or no damage has occurred in the

coupon. When there are irregularities in the parabolic shape of the load curve this indicates that the coupon has undergone extensive damage. These irregularities can be observed in force-time plots of coupons A, B, K and L and they seem to be very consistent. This can also be seen for coupon H which is clearly an outlier.

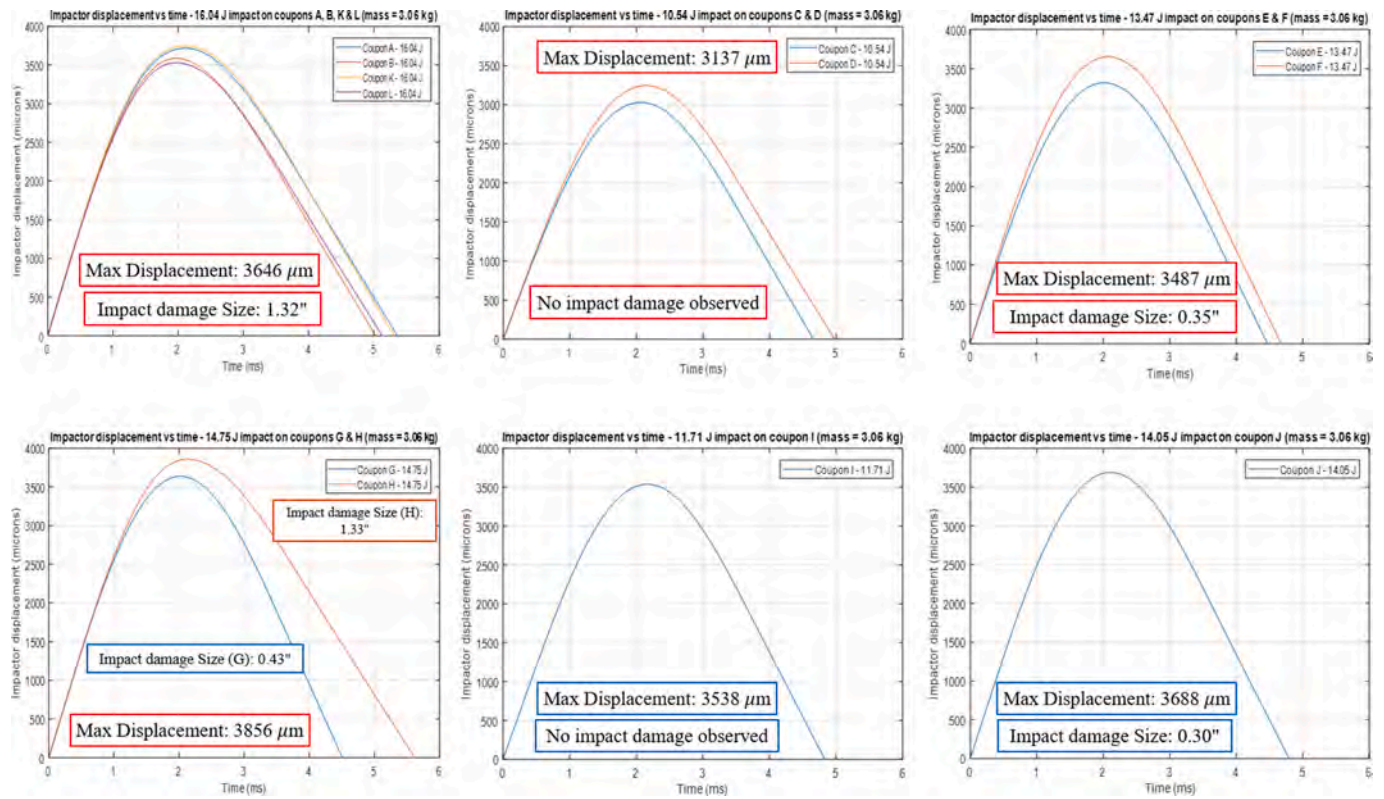
Fig. 17. Displacement-time history of [-45/90/+45/0]_{4s} coupons.

The velocity-time history of the impact events in the 4-mm coupons begins from being positive initially as the impactor is dropped towards the coupon then it becomes zero upon contacting the coupon and becomes negative as the impactor rebounds from the coupon and moves upwards. The displacement-time history of the coupons begins from zero and becomes maximum upon contacting with the impactor and then goes back to zero as the impactor is rebounded upwards as can be clearly observed in Fig. 17. We can clearly observe that the maximum displacement is obtained in coupon G for an impact energy of 14.75 J. Coupon H was an outlier as the same energy did not create any significant damage in coupon G. If we look at the force curves of coupons G and H we will observe that they have almost the same maximum force

but their damage mechanisms are different due to their difference in strength which is anomalous.

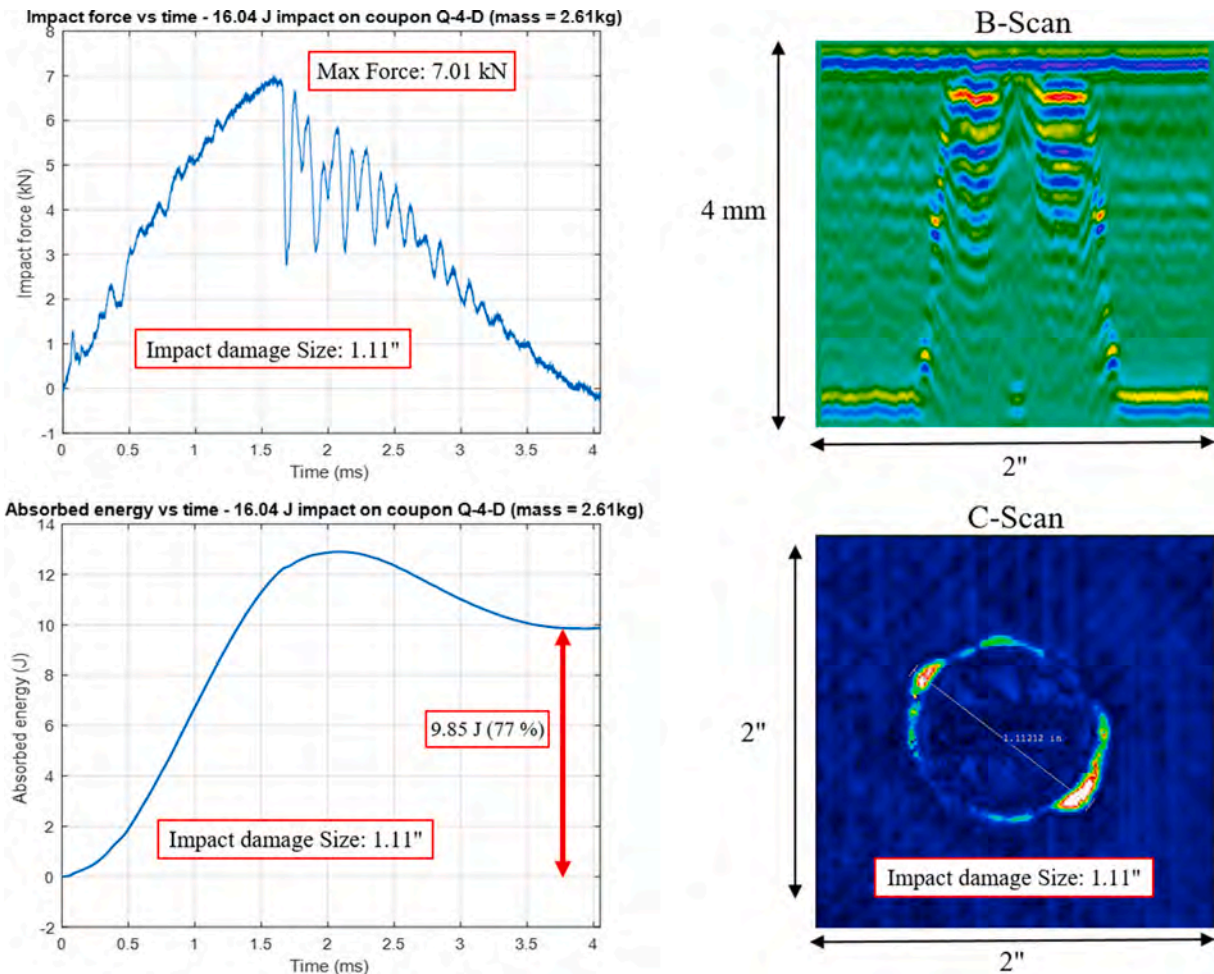
Fig. 21. Quad plot of 4-mm coupon with force-history, energy-history, B-scan and C-scan.

Ultrasonic immersion tank scans were conducted to obtain the B-scan and C-scan images of the impact damage to observe its shape and size. From the B-scan, it can be seen that although, the center of the damage area undergoes permanent deformation similar to a dent, it does not have a delamination as a clear reflection from the center of the damage can be seen in the B-scan and it aligns with the bottom surface of the coupon. In addition, it can also be observed that the impact damage has propagated all the way through the thickness of the composite similar to the 2-mm coupon. From the C-scan image, we can clearly see that there is a small fiber pushout in the -45° fiber direction, and this can be seen by looking at the rear surface of the coupon as well. A quad plot of a representative coupon, displaying the force-time history, the

energy time history, The B-scan and C-scan is observed in Fig. 21.

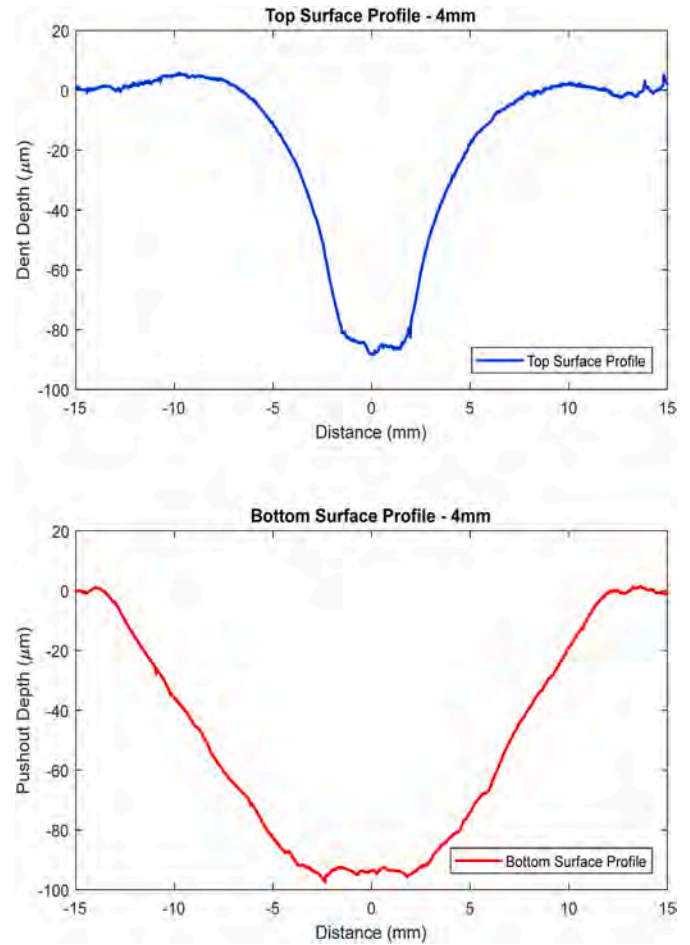
Fig. 23. Profilometry scans of 4-mm coupon: (a) Top surface; (b) Bottom surface.

Profilometry scans of the coupon were conducted similar to the previous section to observe the profile of the top and bottom surface after impact. The profilometry images are displayed in Fig. 23. Using the top surface scan, we were able to estimate that the dent depth is approximately 87 μm and using the bottom surface scan we were able to

estimate the pushout height as 97 μm . As can be observed, the bottom surface of this coupon in Fig. 23 (b) has much lesser the irregularities when compared to the bottom surface of the 2-mm coupon in Fig. 23 (b). It is also interesting to observe that the dent profile seems a little flatter compared to the 2-mm coupon with a small dimple. The flatness in the surface profile is attributed to the additional 45° and -45° laminas in the 4-mm coupon which increases the flexural stiffness of the composite and therefore the coupon resist the bending due to impact.

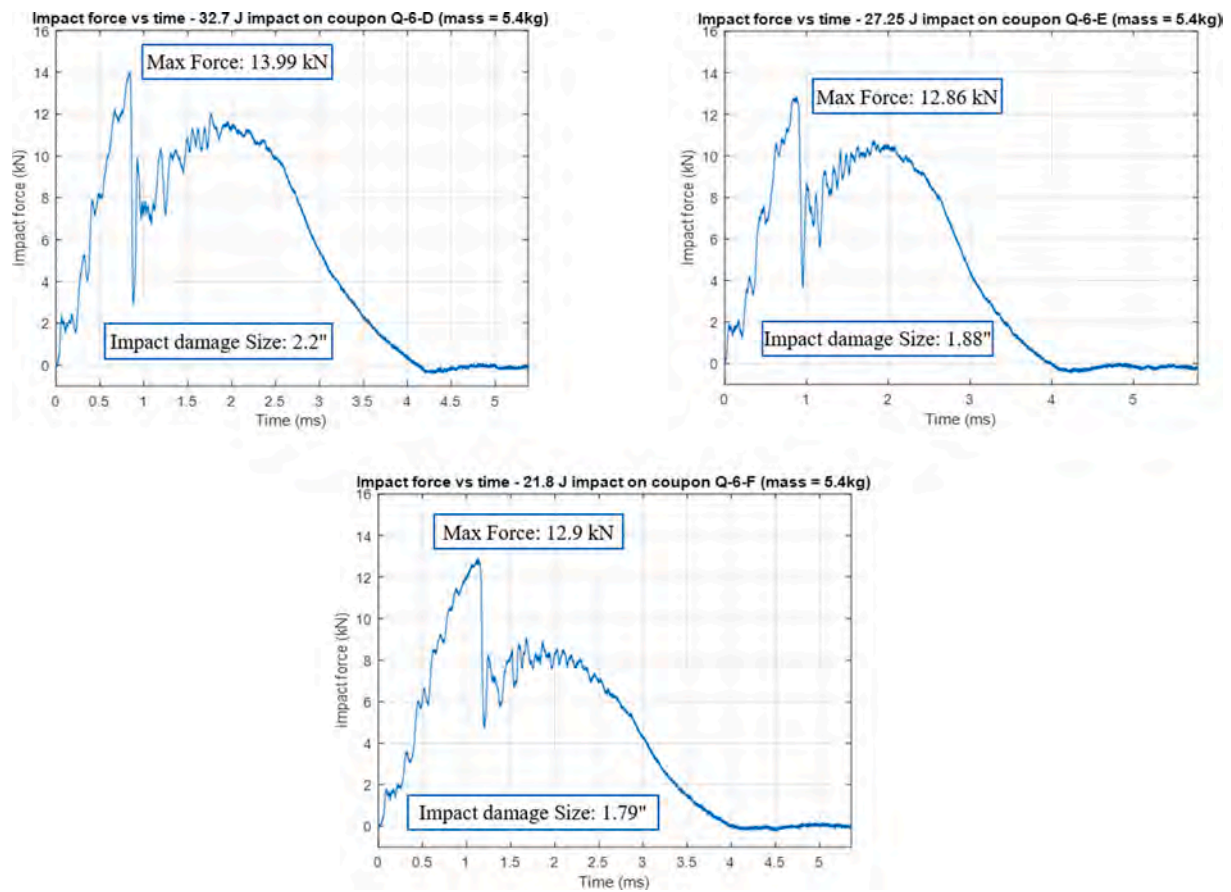
Fig. 26. Force-time history of $[-45/90/+45/0]_{6s}$ coupons Q-6-D, Q-6-E and Q-6-F.

The force-time history of the impacts are given in Fig. 24, Fig. 25 and

Fig. 26. The force-time curve shows peaks at certain maximum load and is parabolic in shape. When the load curve is symmetric, its shape indicates that the impact energy is primarily deflected and little or no damage has occurred in the coupon. When there are irregularities in the parabolic shape of the load curve this indicates that the coupon has

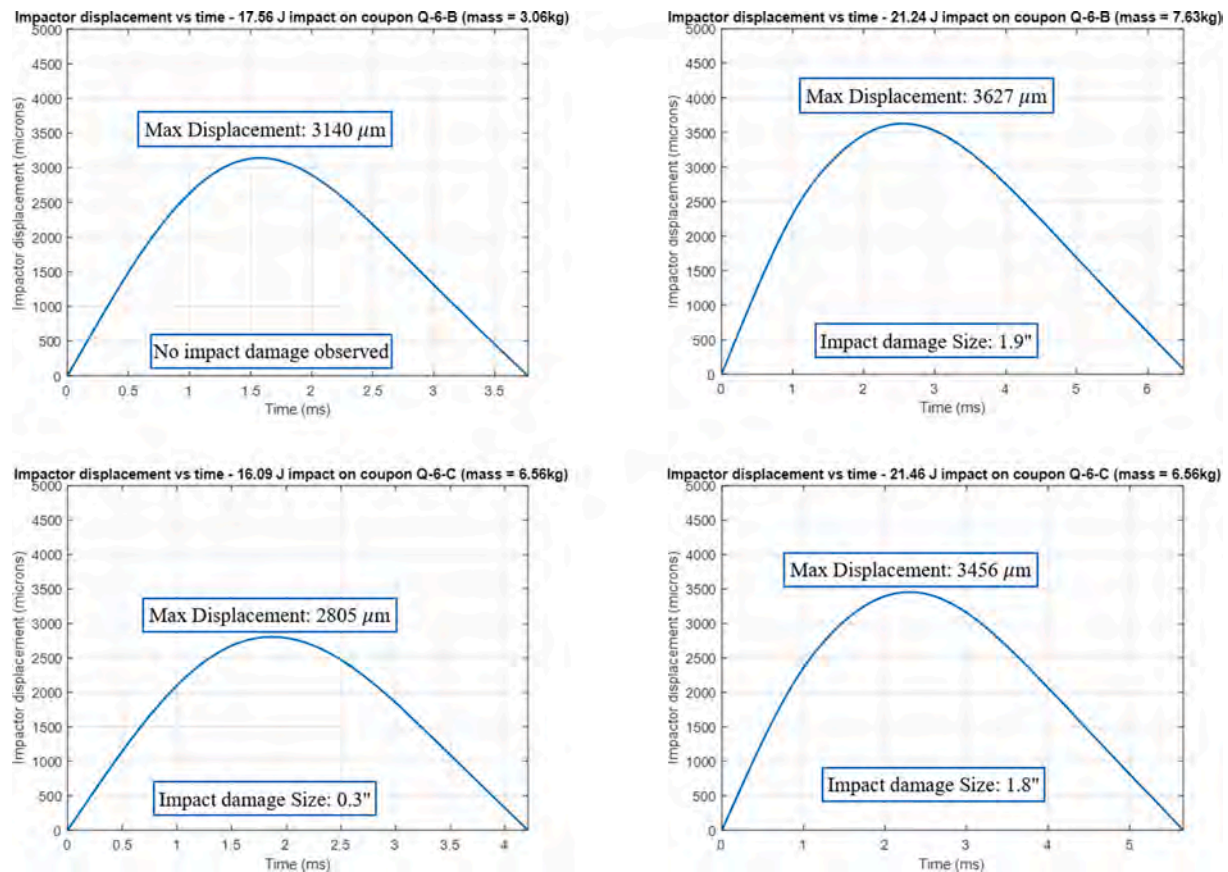
Fig. 28. Displacement-time history of $[-45/90/+45/0]_{6s}$ coupons Q-6-B and Q-6-C for multiple impacts.

The velocity-time history of the impact events in the 6-mm coupons is similar to the behavior described for the 2-mm and 4-mm coupons. The displacement-time history of the coupons also has a similar trend as displayed by previous coupons and can be clearly observed in Fig. 27, Fig. 28 and Fig. 29.

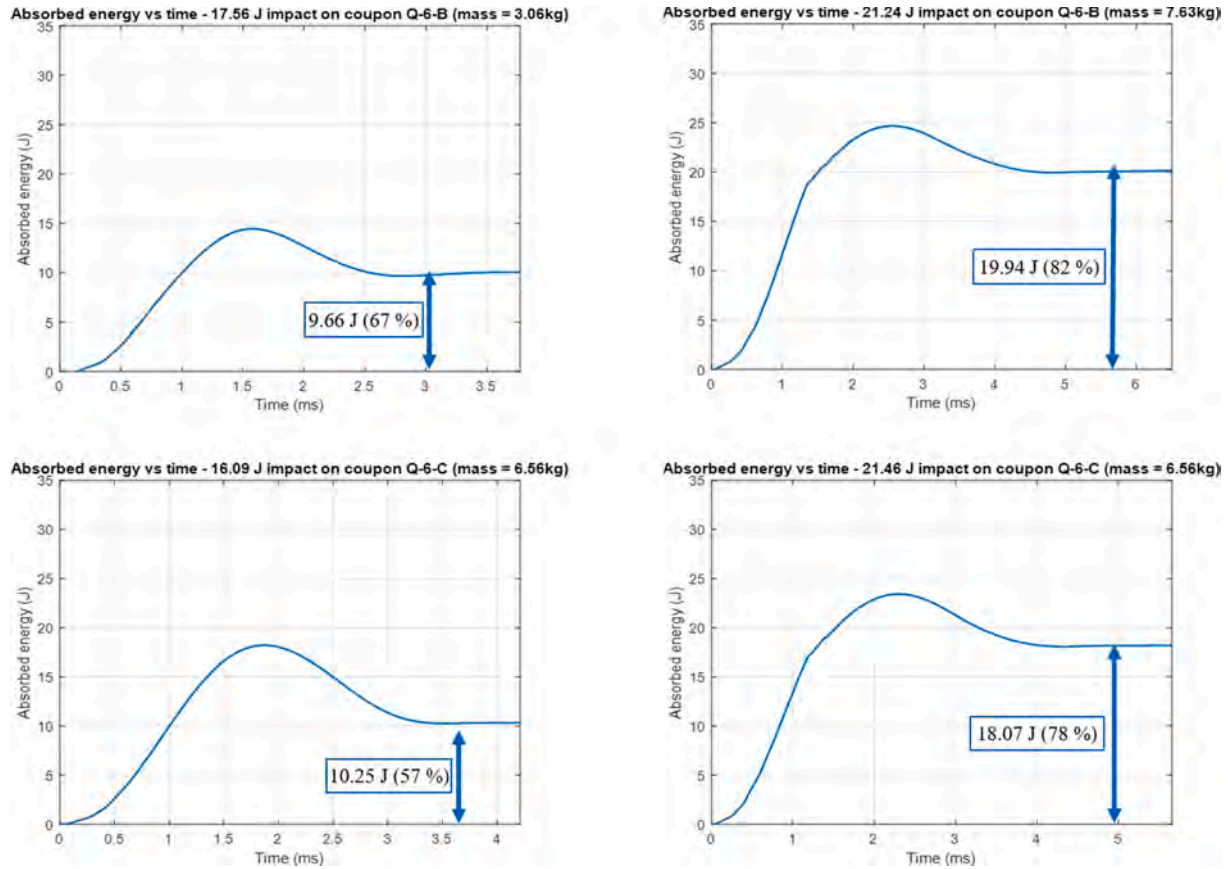
Fig. 31. Energy-time history of $[-45/90/+45/0]_{6s}$ coupons Q-6-B and Q-6-C for multiple impacts.

The energy-time plots given in Fig. 30, Fig. 31 and Fig. 32 is taken from the force-time curve through integration of the data. The energy-time history clearly is able to demonstrate the percentage of impact energy that is absorbed by the coupon to create the irreversible process of damage. Similar to the 4-mm plate, there seems to be a threshold phenomenon occurring where if the absorbed energy is more than 79%, it creates a impact damage diameter of 1.7" or more in the 6-mm plate.
